INDOOR AIR QUALITY ASSESSMENT

**Berkshire Community College
Hawthorne Hall
1350 West Street
Pittsfield, MA**

Prepared by:
Massachusetts Department of Public Health
Bureau of Environmental Health
Indoor Air Quality Program
August 2017

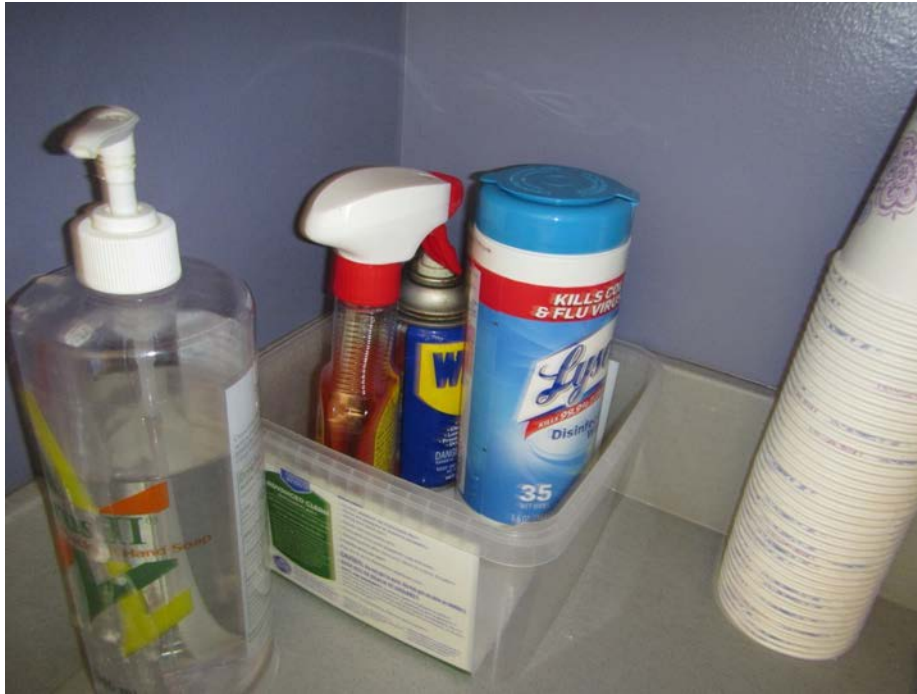
Picture 1

Other conditions that can affect IAQ were observed during the assessment. Exposure to low levels of total volatile organic compounds (TVOCs) may produce eye, nose, throat, and/or respiratory irritation in some sensitive individuals. To determine if VOCs were present, BEH/IAQ staff used a photo ionization detector (PID) to measure TVOCs. No measurable TVOCs were detected at the time of the assessment. BEH/IAQ staff noted hand sanitizers, cleaners/wipes and air deodorizers in use within the building (Pictures 1 and 2). All of these products have the potential to be irritants to the eyes, nose, throat, and respiratory system of sensitive individuals. MDPH typically recommends limiting the use of these items to avoid irritant effects on occupants.

Assorted cleaners/wipes

6. Reduce the use of or eliminate products containing VOC’s in the building (harsh cleaners/wipes, hand sanitizers, etc.).
7. Continue to keep dry erase board trays free from debris to avoid irritant effects.

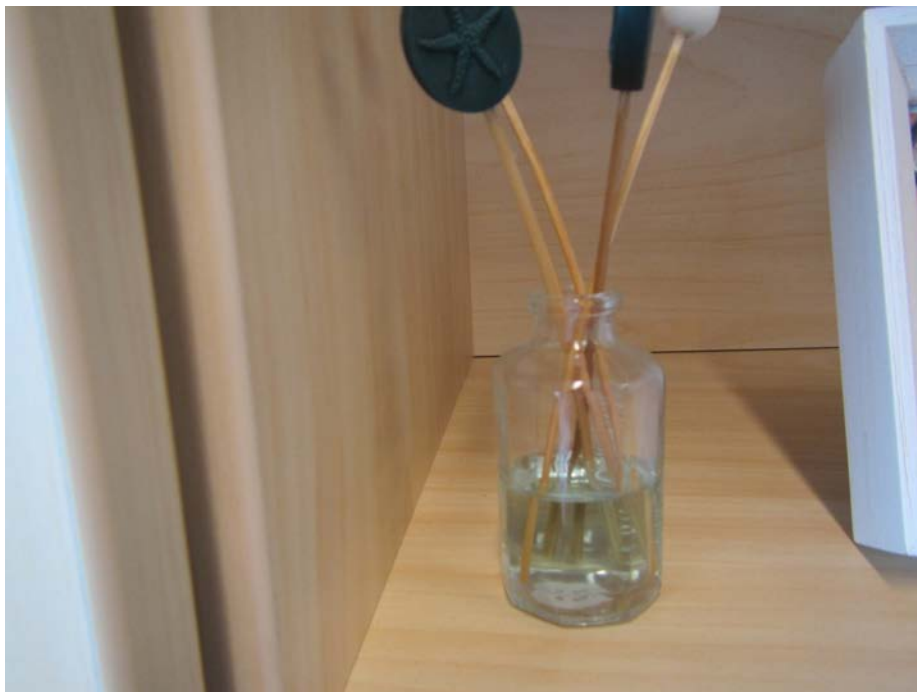
Picture 2

Reed diffuser air deodorizer in office area

5. Eliminate the use of scented items, including air deodorizing sprays, reed diffusers and scented cleaners to prevent respiratory irritation. Consider adopting a “fragrance-free” policy campus-wide.

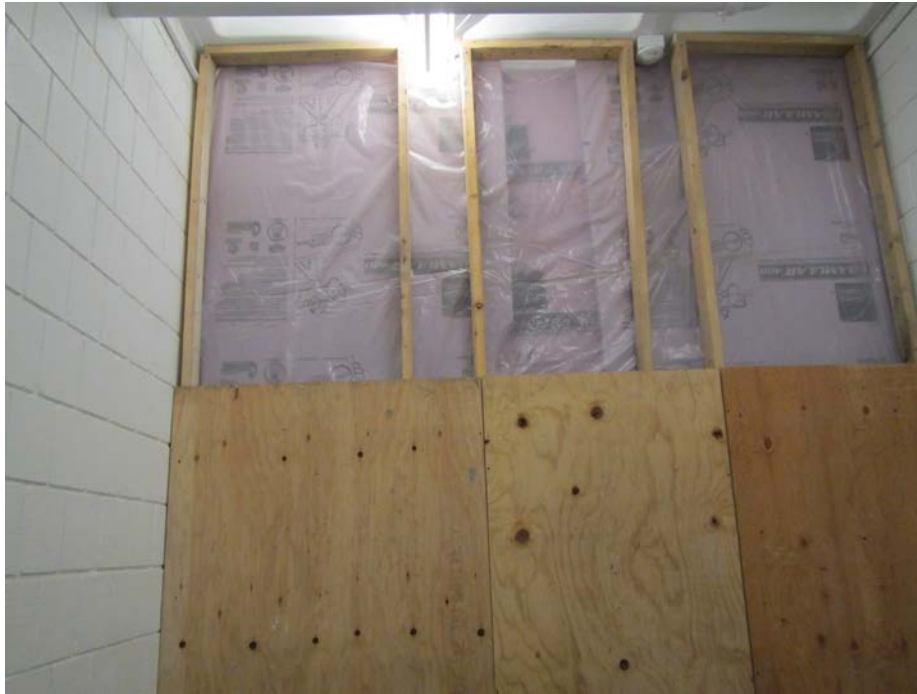
Picture 3

Construction activities were being performed outside of HH to connect it to Melville Hall at the time of this assessment (Picture 3). BCC staff should ensure that contractors continue to follow the MDPH guideline “Methods Used to Reduce/Prevent Exposure to Construction/Renovation Generated Pollutants in Occupied Buildings” (MDPH, 2006).

Barrier separating occupied area from active construction

1. Continue to follow MDPH guidelines (MDPH, 2006) concerning renovations while building is occupied.
2. Continue to perform regular HEPA vacuuming and wet-wiping of surfaces to reduce the risk of aerosolized dust/debris from construction activities. This should include regular FCU cleaning.

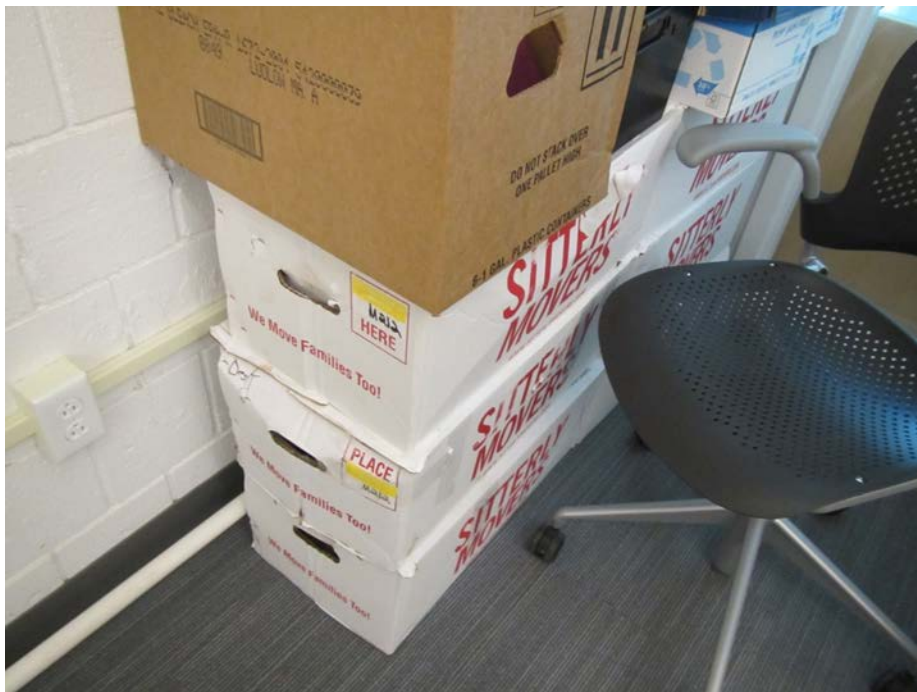
Picture 4

Some areas were noted to have boxes on the floor (Picture 4). Porous items such as cardboard, paper, clothing, etc. should be stored off of the ground especially on ground floor areas (on slab). This will decrease the likelihood of the items accumulating moisture due to condensation.

Boxes of items stored directly on the floor

8. Porous items such as cardboard, paper, clothing, etc. should be stored off of the ground especially on ground floor areas (on slab) to decrease the likelihood of these items accumulating moisture due to condensation.

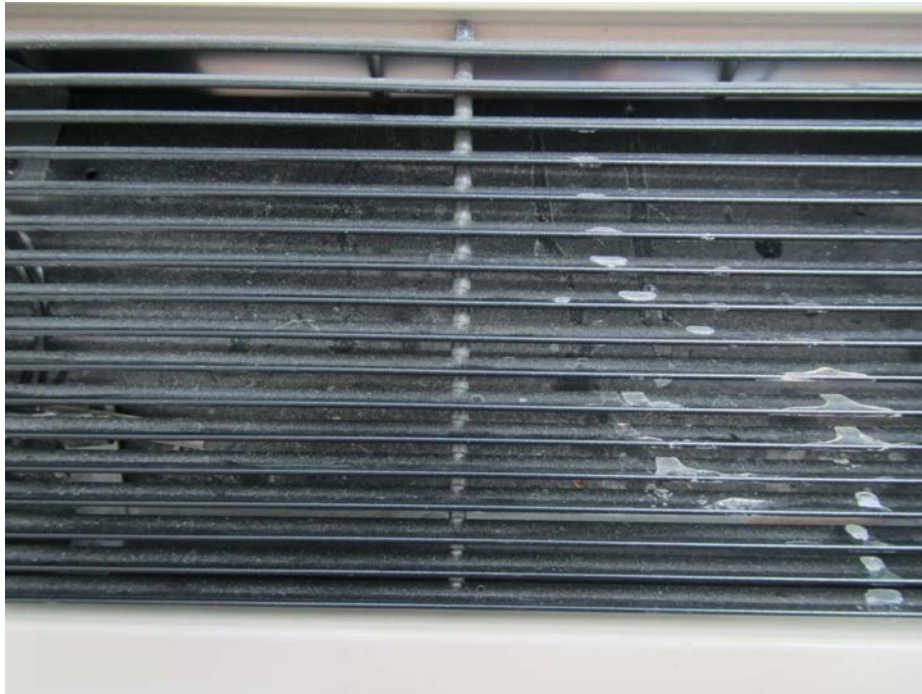
Picture 5

Some FCUs were noted to be dusty (Picture 5). FCUs should be cleaned regularly with a high efficiency particulate arrestance (HEPA) vacuum and wet-wiped to avoid aerosolizing accumulated dust/debris.

Fan coil unit (FCU) showing accumulated dust

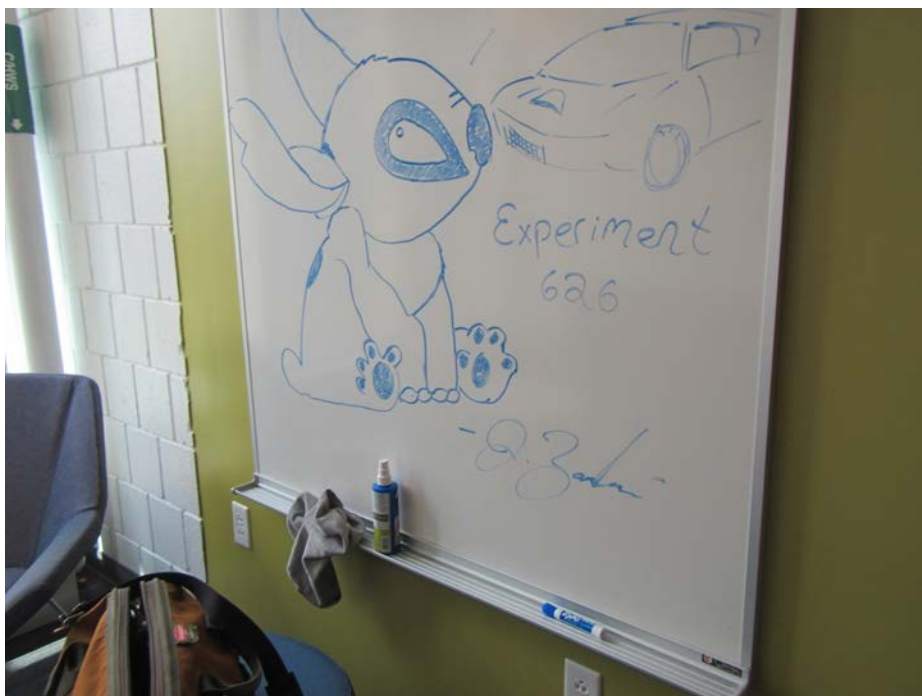
Picture 6

Many rooms have dry erase boards and materials (Picture 6). It is important to continue to avoid accumulations of dry erase residue in the trays. This residue may have irritant effects when aerosolized.

Dry erase materials (DEM)
